## INSPECTION RESULTS BELOW

| Vehicle Information | |
|---|---|
| VIN: 3KPFK4A72JE197253 | |

| Inspection Information | |
|---|---|
| Date | 02/04/21 |

**2018 KIA FORTE**  
**VIN: 3KPFK4A72JE197253**

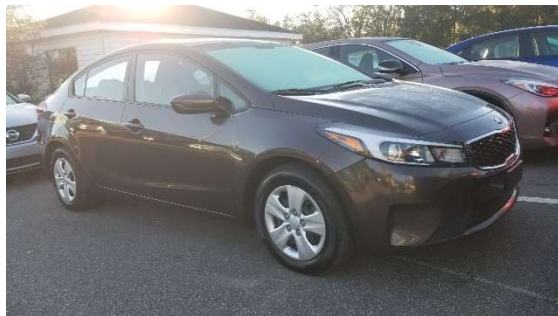
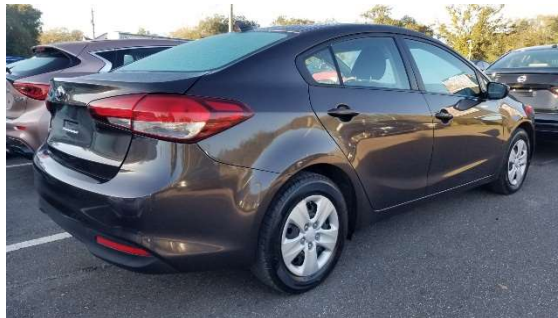
**VERY MINOR COSMETIC  
REPAIRS FOUND**

| Cosmetic | Analytics |
|---|---|
| Rear Bumper Cover | Repaired |
| Left Quarter Panel | Repaired |

\*If any, Repairs will be noted on vehicle with RED indicator.
